Canadian Natural

PRIMROSE UPDATE

Reporting Period September 22-28, 2013

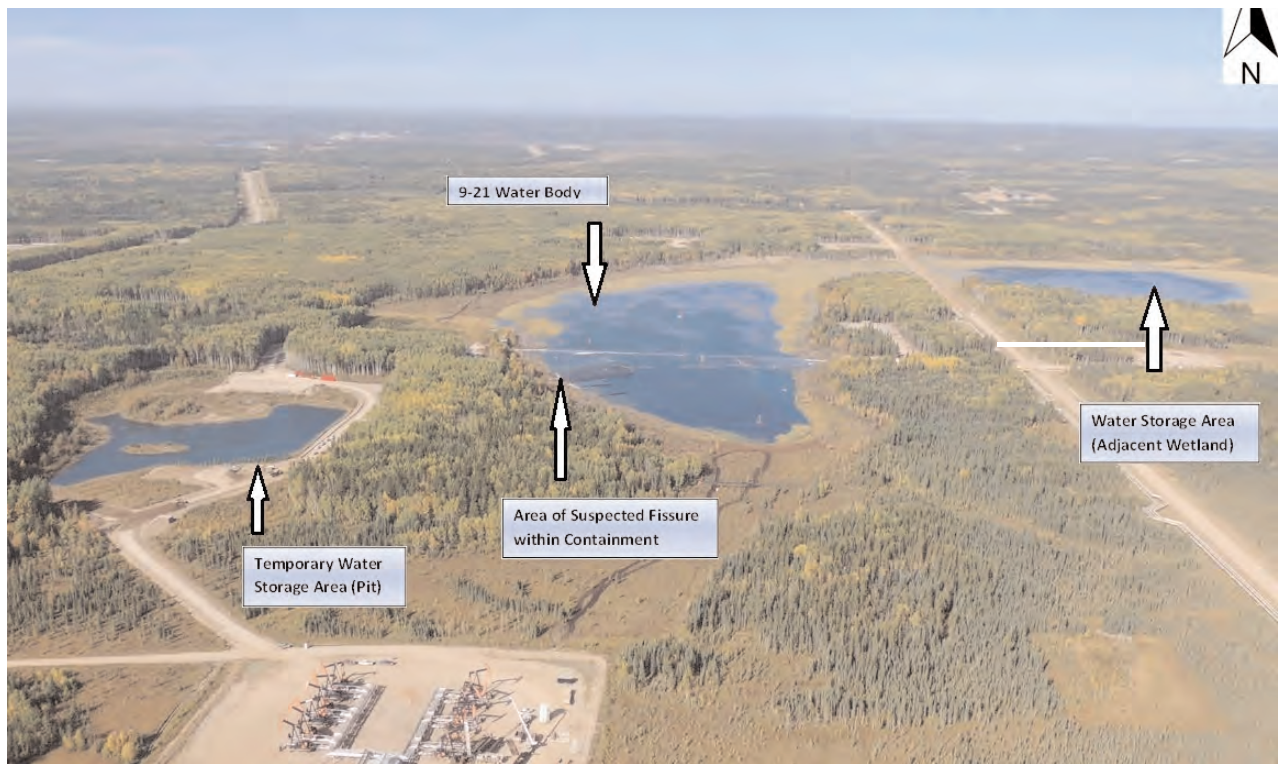
Photo: Aerial Photograph of the 9-21 Site

On September 3, 2013 Canadian Natural requested, and received on September 24, 2013 an Environmental Protection Order for the 9-21 site from Alberta Environment and Sustainable Resource Development (ESRD). This order will allow us to isolate, excavate and contain the fissure that is below the water body. To facilitate this work, the water from the area will be moved and stored near-by and returned the following year. On September 27, 2013 we commenced de-watering. We appreciate the ongoing support from the Alberta Energy Regulator and ESRD as we continue to manage these events.
